TURBINE TIP CLEARANCE MEASUREMENT

Lawrence C. Baker, Gordon E. Grady, Hagen R. Mauch

General Electric Company
Aircraft Engine Group
1000 Western Avenue
Lynn, Mass. 01910

March 1978

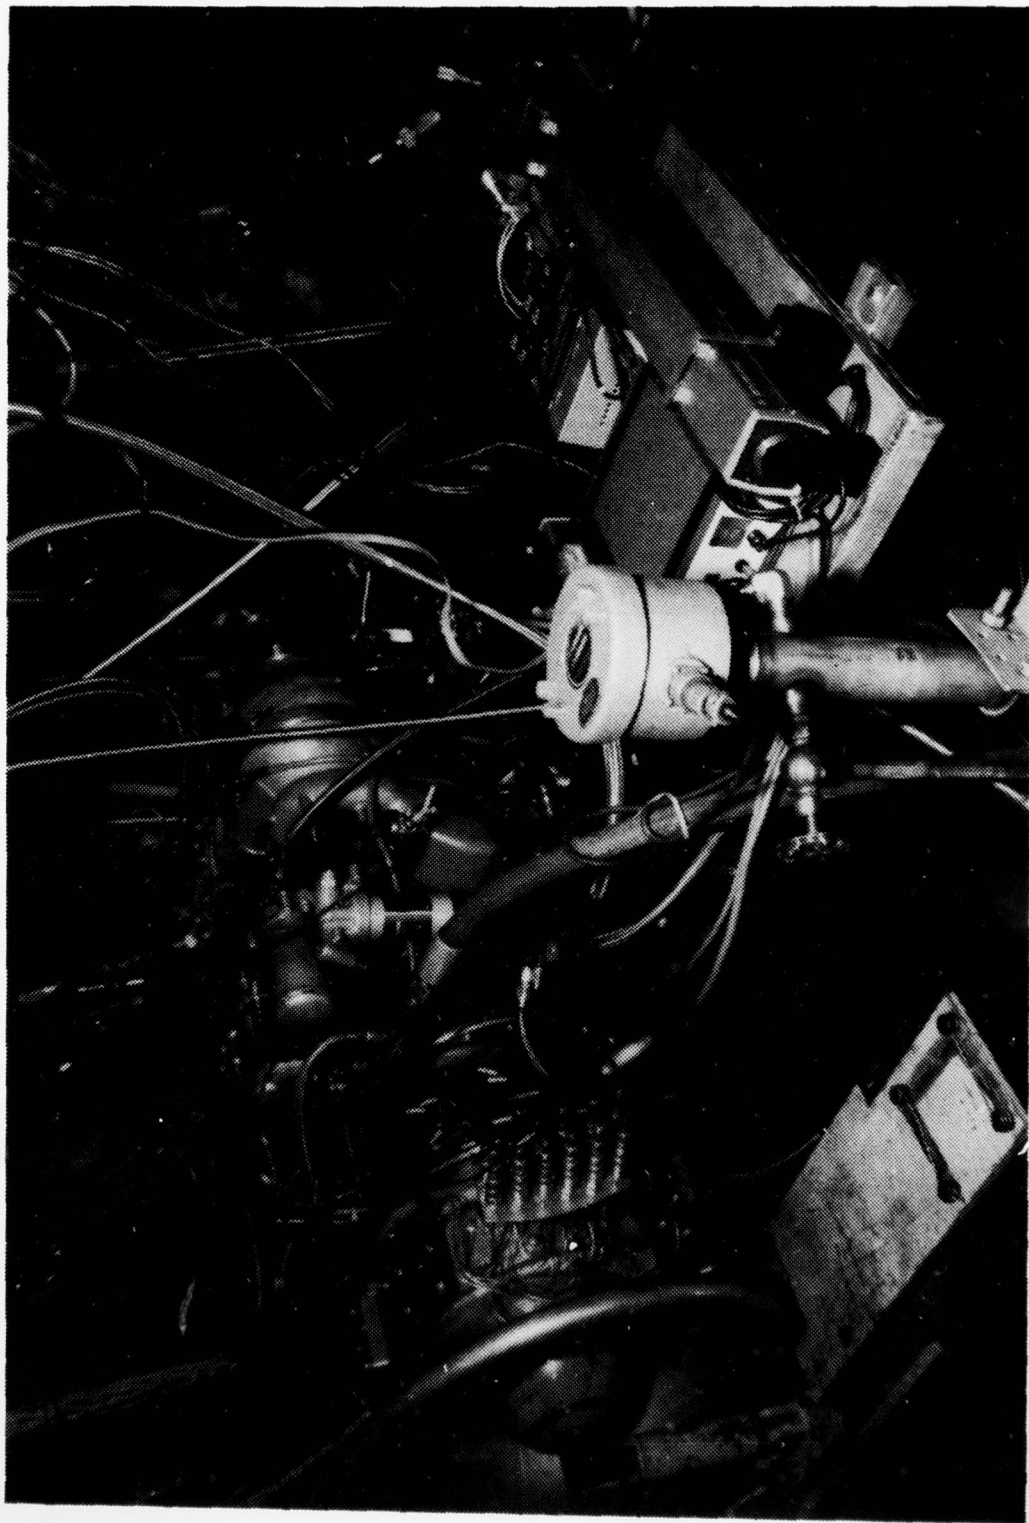
Figure 42. Typical Engine Installation Without Optical Band-Pass Filter.

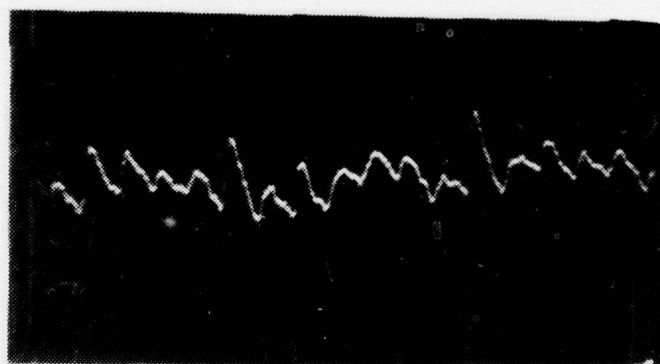
Figure 43. Output of TTMC Without Optical Filter - Engine at 28,850 RPM.

Following the initial test, further investigation proved that the long transmission cables between the engine-mounted electronics and control room readouts caused the amplifiers to oscillate and reversed the polarity of the signal when the oscillations were not present. When the signals were monitored in the test cell with a short cable, the polarity of the signal was correct and the high-frequency oscillations disappeared. The engine was rotated manually to obtain signals while performing these checks.

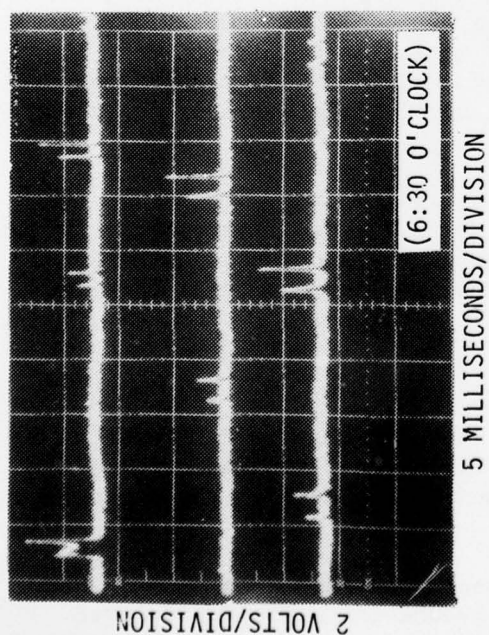
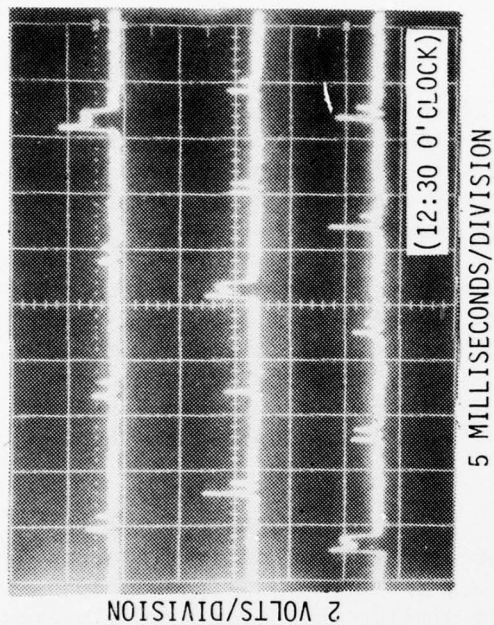
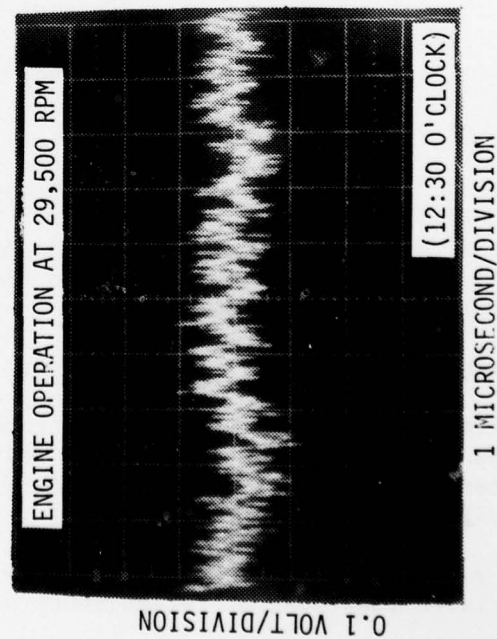
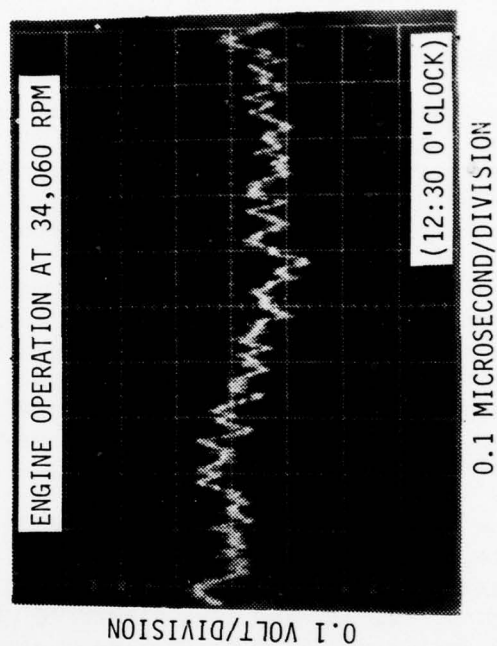
ENGINE MANUALLY ROTATED

Figure 44. System Output For Engine Manual Rotation and Engine Operation at 29,000 and 34,060 RPM.

Further review of the data and systems indicated that during the motoring, electrical interference was evident. Additionally, damage was noted in one fiber optic bundle.

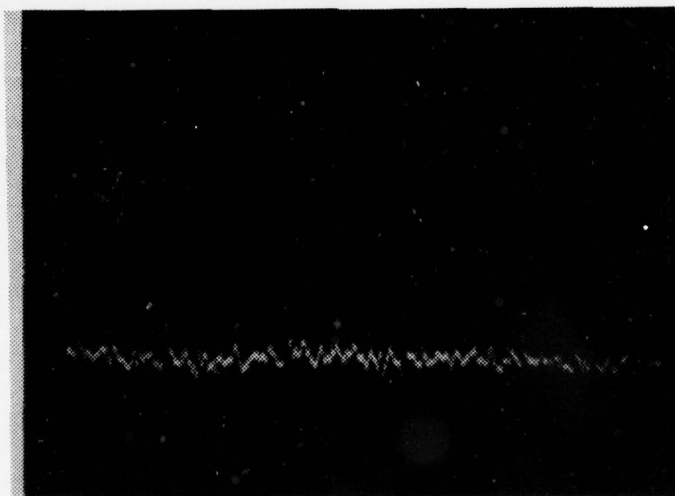
ON-LINE OSCILLOSCOPE PHOTOGRAPH AT 29,000 RPM (IDLE), SHOWING APPARENT CLEARANCES OF (FROM LEFT TO RIGHT): BLADE NO. 1 = 0.045 INCH, NO. 8 = 0.042 INCH, NO. 15 = 0.0435 INCH, NO. 22 = 0.048 INCH, AND NO. 29 = 0.040 INCH.

Upper photograph was taken early in the 5-minute run, while the lower photograph was taken two to three minutes later in the same run. Note the deterioration in the signal level.

Figure 47. Probe Readings at 6:30 O'Clock - 29,000 RPM.

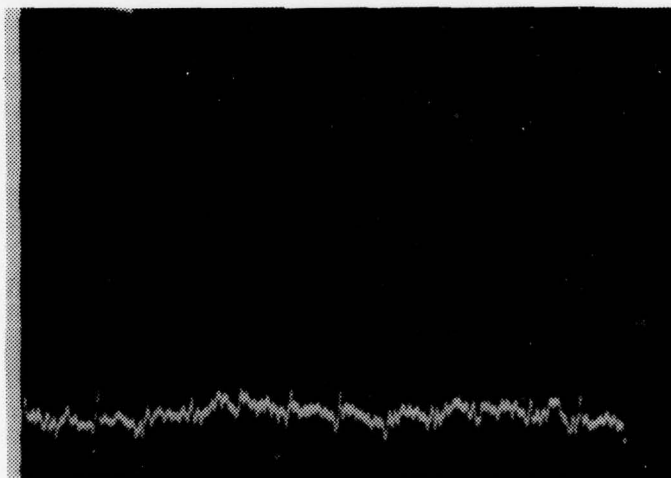
ON-LINE OSCILLOSCOPE PHOTOGRAPH AT IDLE (29,000 RPM)

The above data was suspected to be incorrect because of apparent damage to the input fiber optic bundle. The low levels are indicative of the problem; however, the waveform still shows the solid tip blades.

Figure 49. Probe Readings at 12:30 O'Clock.

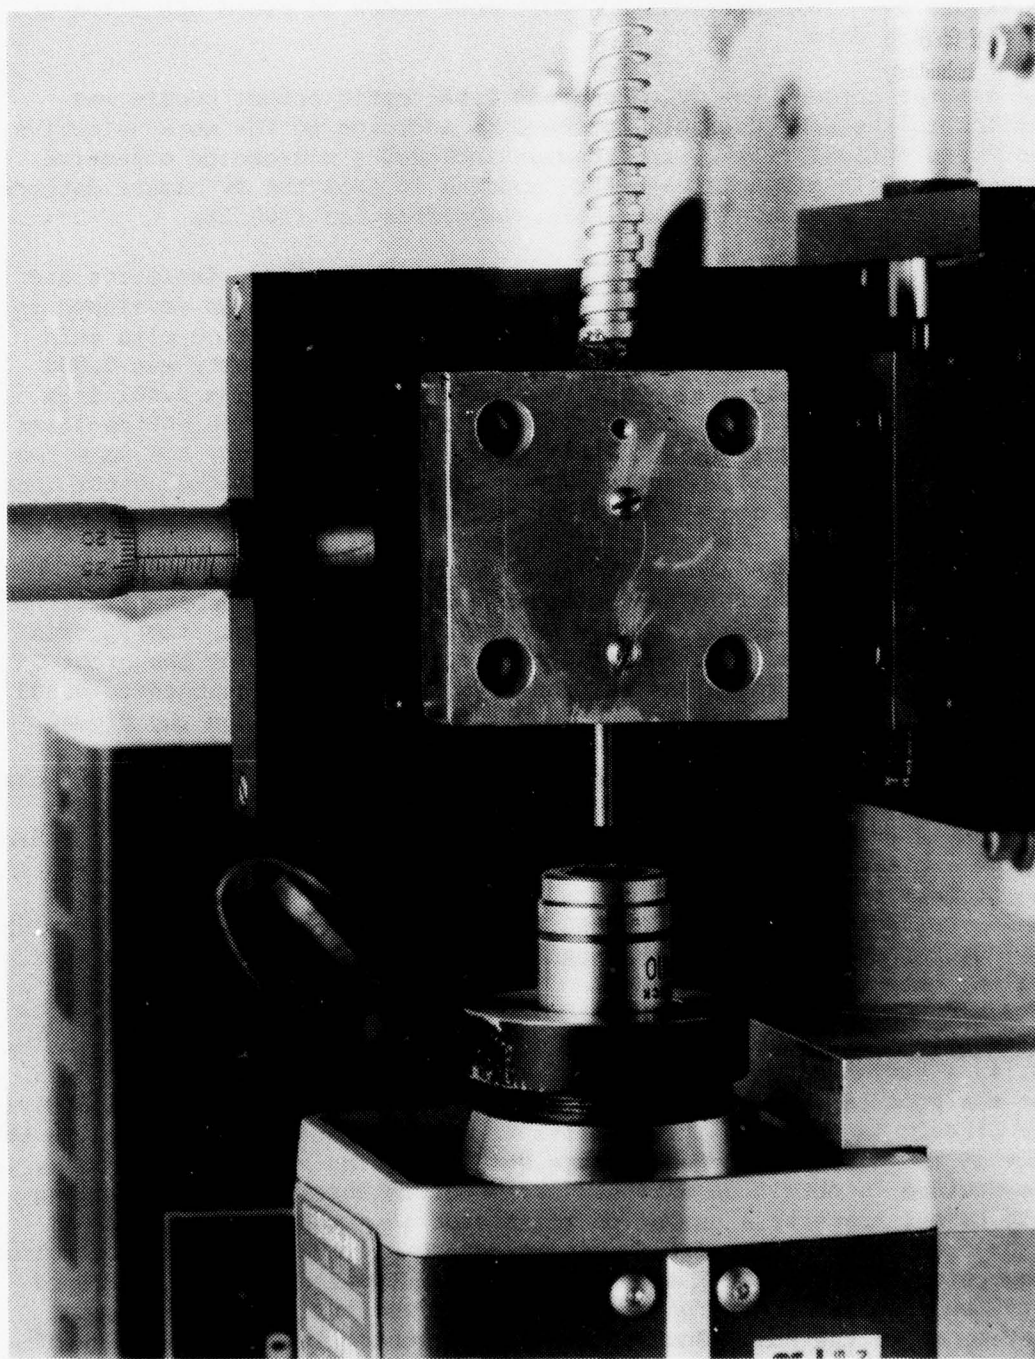
Figure 50. Three-Axis Positioning System.

Installation Changes: Each laser was rigidly clamped on a water-cooled base so that there would be no motion relative to its illuminated fiber optic bundle. The laser was allowed to expand thermally only at the rear mounting. The returning (output) fiber optic bundle was clamped in a fixture to its detector and to the mounting plate. Each plate held an enclosure for heat and noise isolation, and each probe, including the touch probe, received forced air cooling of exposed components as well as the original cooling system.

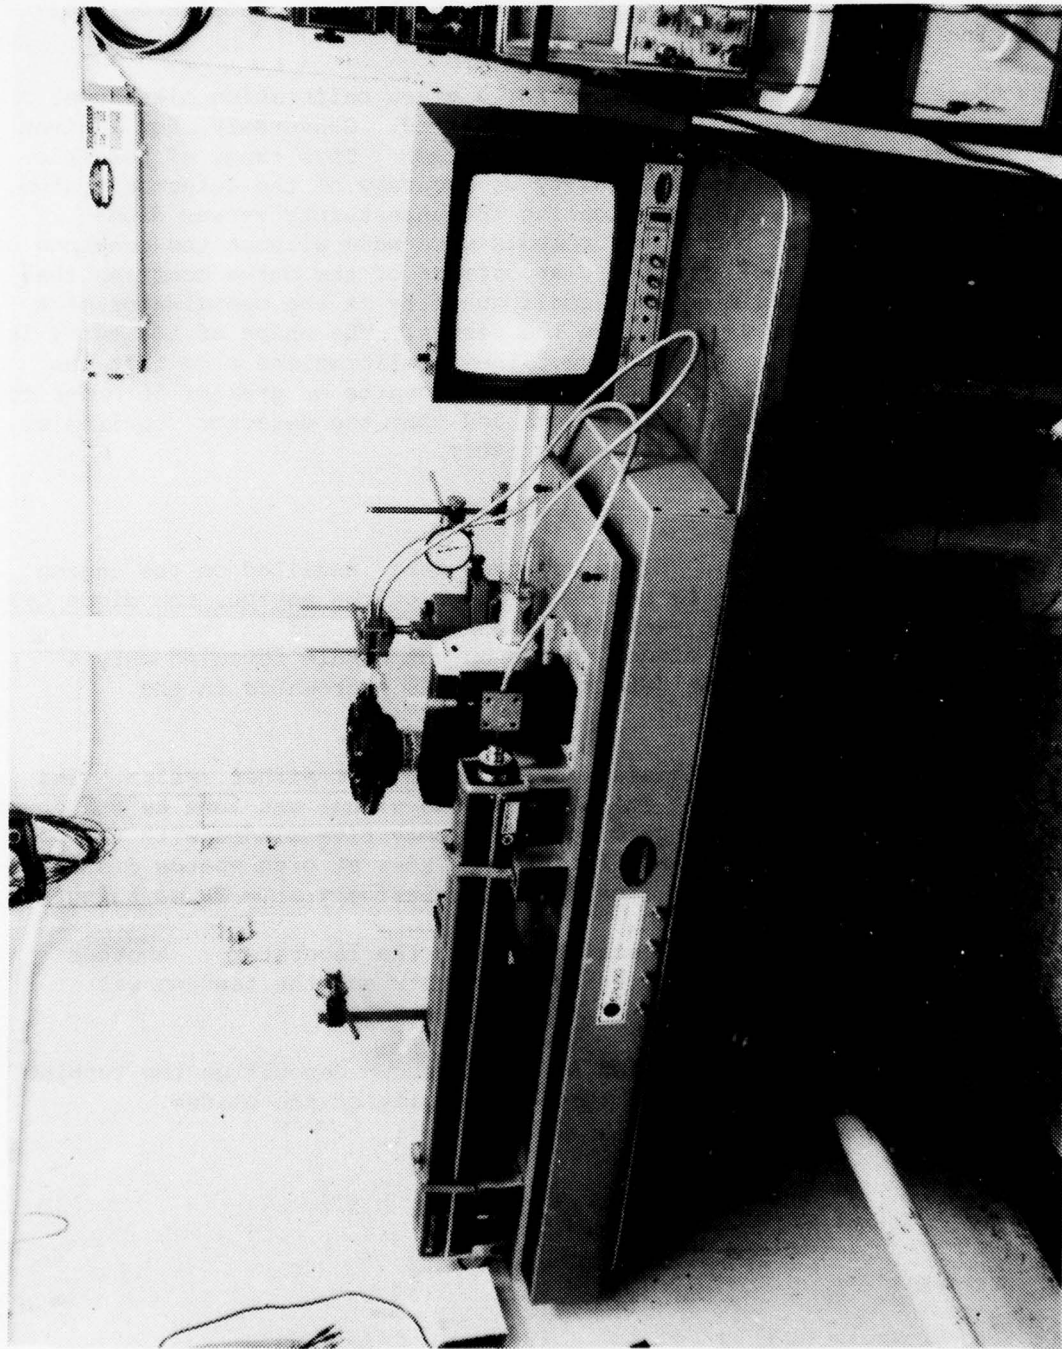
Figure 51. MTCMD TV System.

TV System: Prior to the fourth engine test, a TV (MTCMD) position detection system was constructed. The laboratory calibration setup is shown in Figure 51. This provided an additional check on probe operation and on clearance data.

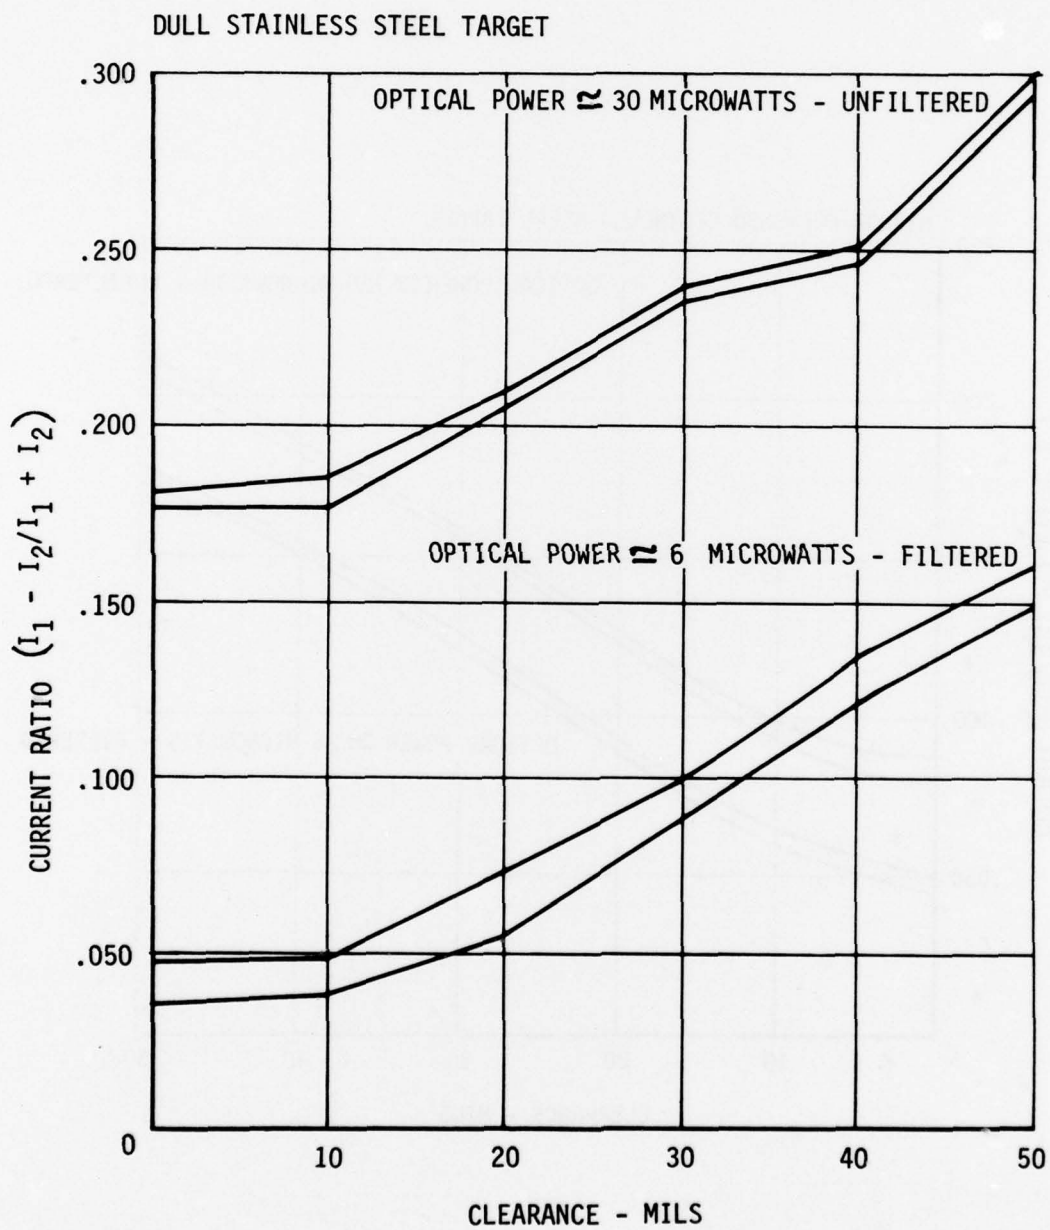
Figure 53. Calibration With Dull Target.

Figures 52 through 56 show that not only is the calibration sensitive to target reflectivity (all curves should ideally be the same), but there is a striking correlation between the spread in the curve and the optical power incident on the detector.

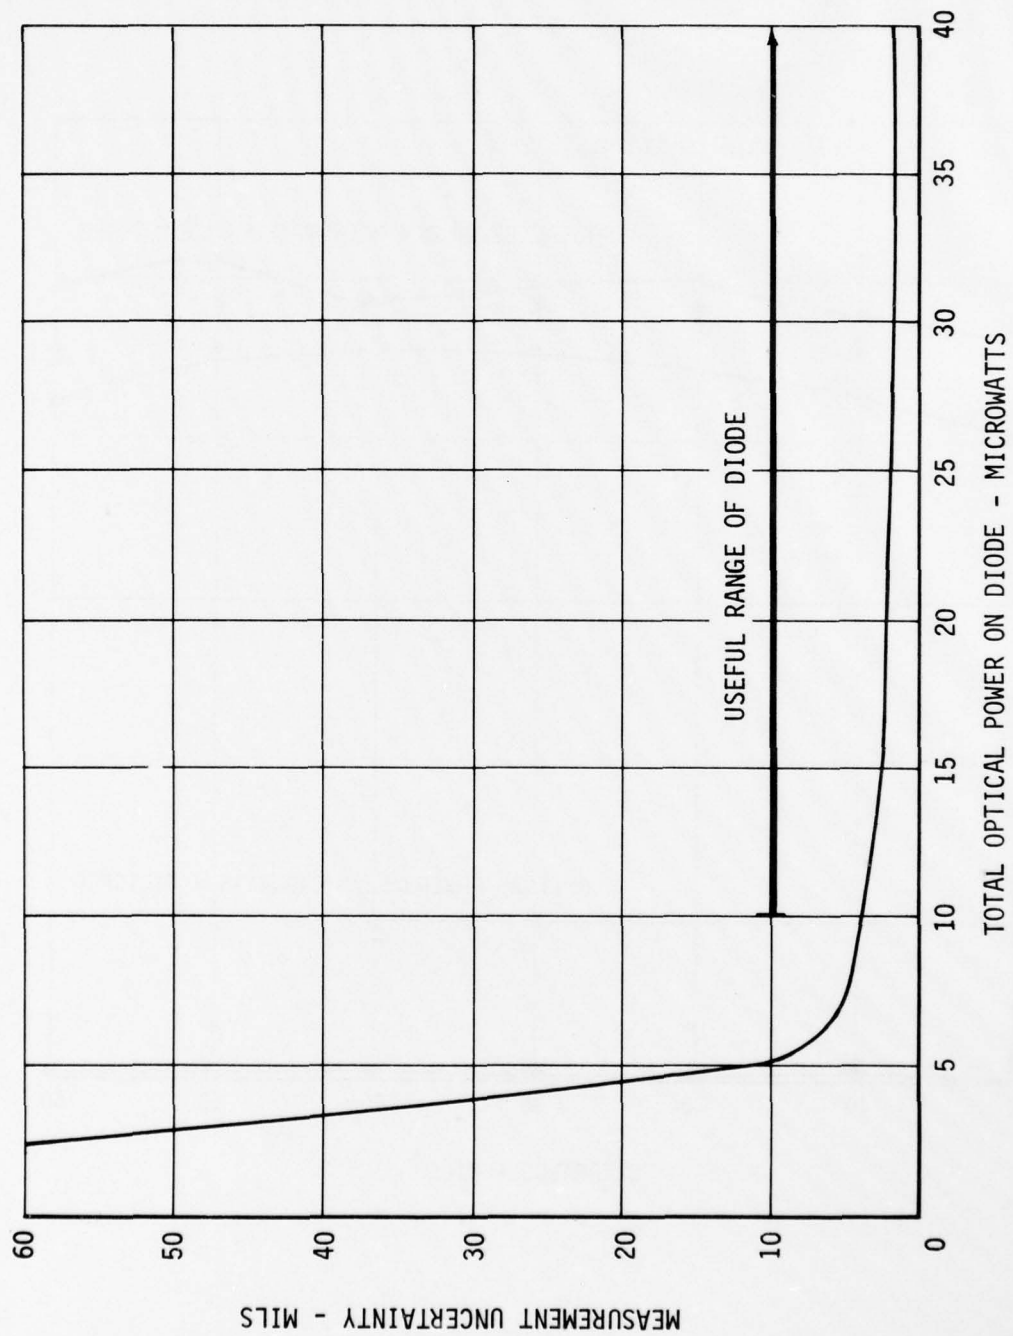
Figure 57. Clearance Uncertainty for Various Target Outputs.

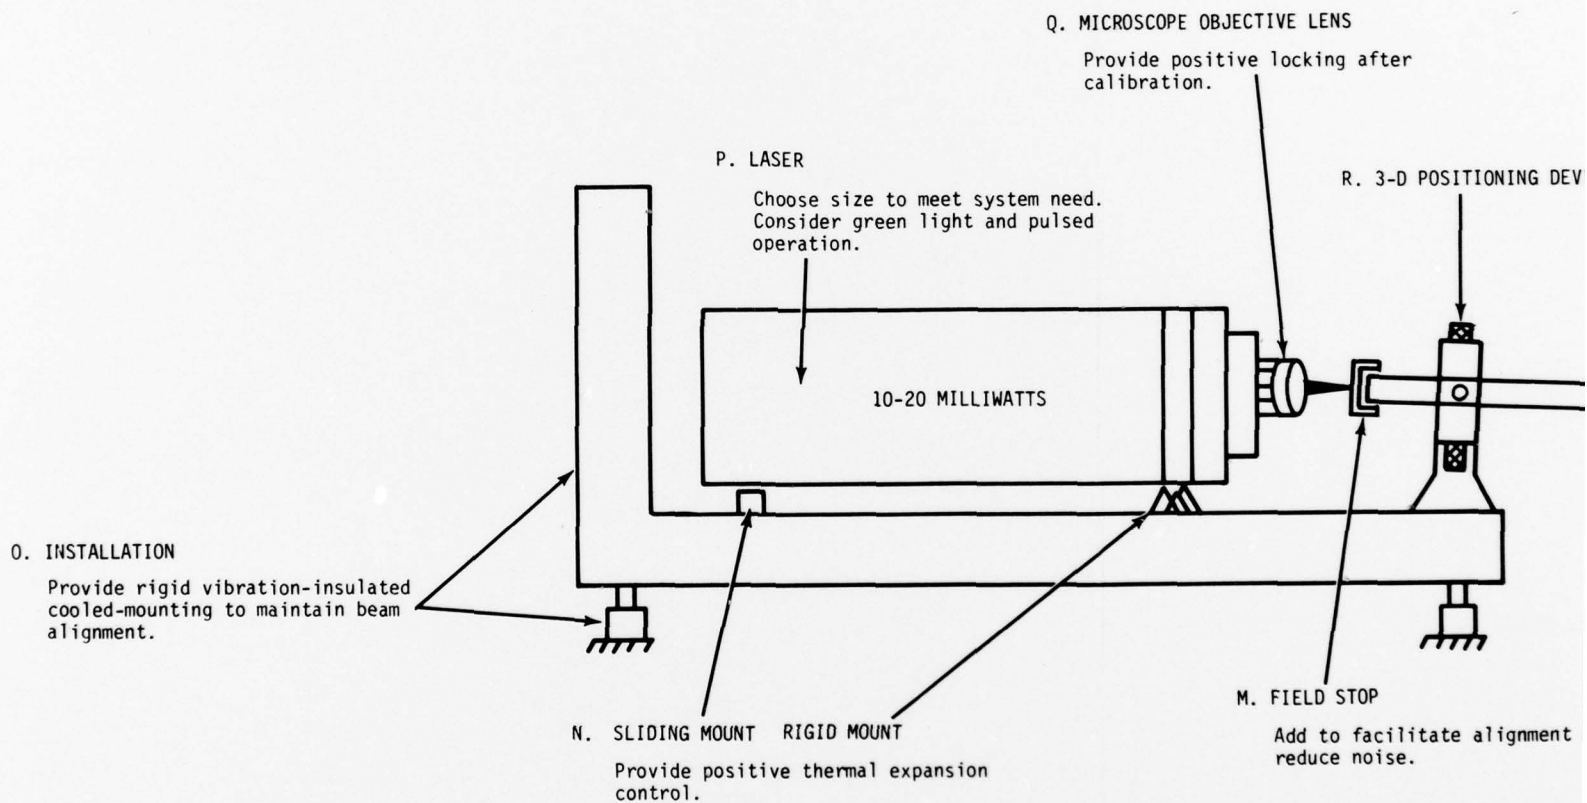
Figure 58. Tip Clearance Measurement Device Recommended Design Changes.

Blade Tip Reflectance: For general use, the system should function with blade tips which have realistic oxidation levels and corresponding reflectivity. The power input versus output should recognize these realistic requirements when setting laser power requirement (Item P). For experimental use, a polished coating on the tip could be developed. CODEP was not confirmed as a suitable coating on this program.

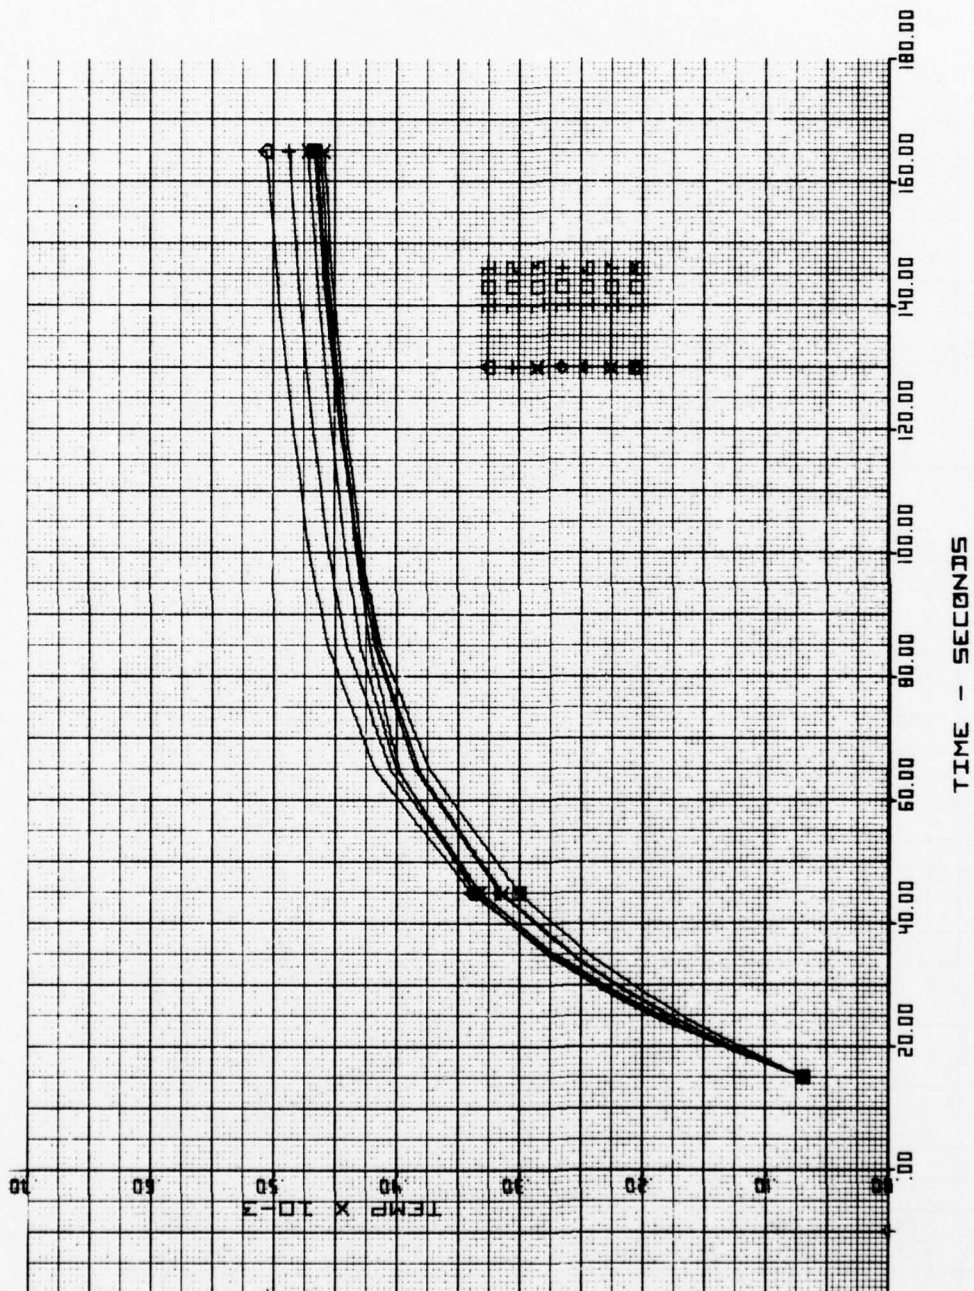
Figure A1. Forward Cooling Plate - Cold Start.

The temperature response characteristics are shown in Figures A1 through A61 for each of the steady-state and transient engine conditions studied. The key for the turbine rotor temperature nodes is shown in the nodal model of Figure 4 and those of the turbine stator are shown in Figure 5.

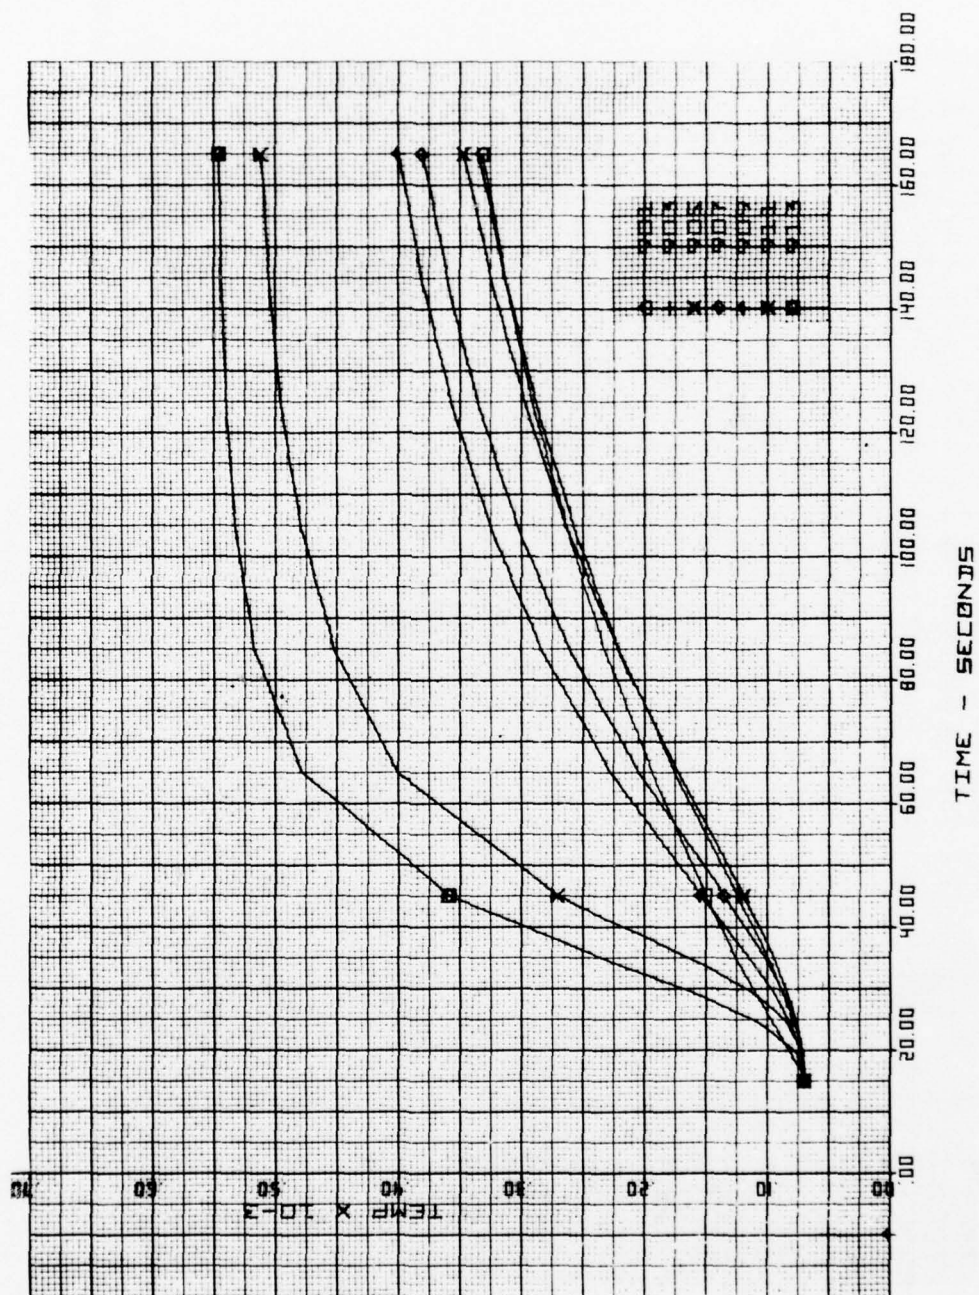
Figure A7. Disk - Cold Start.

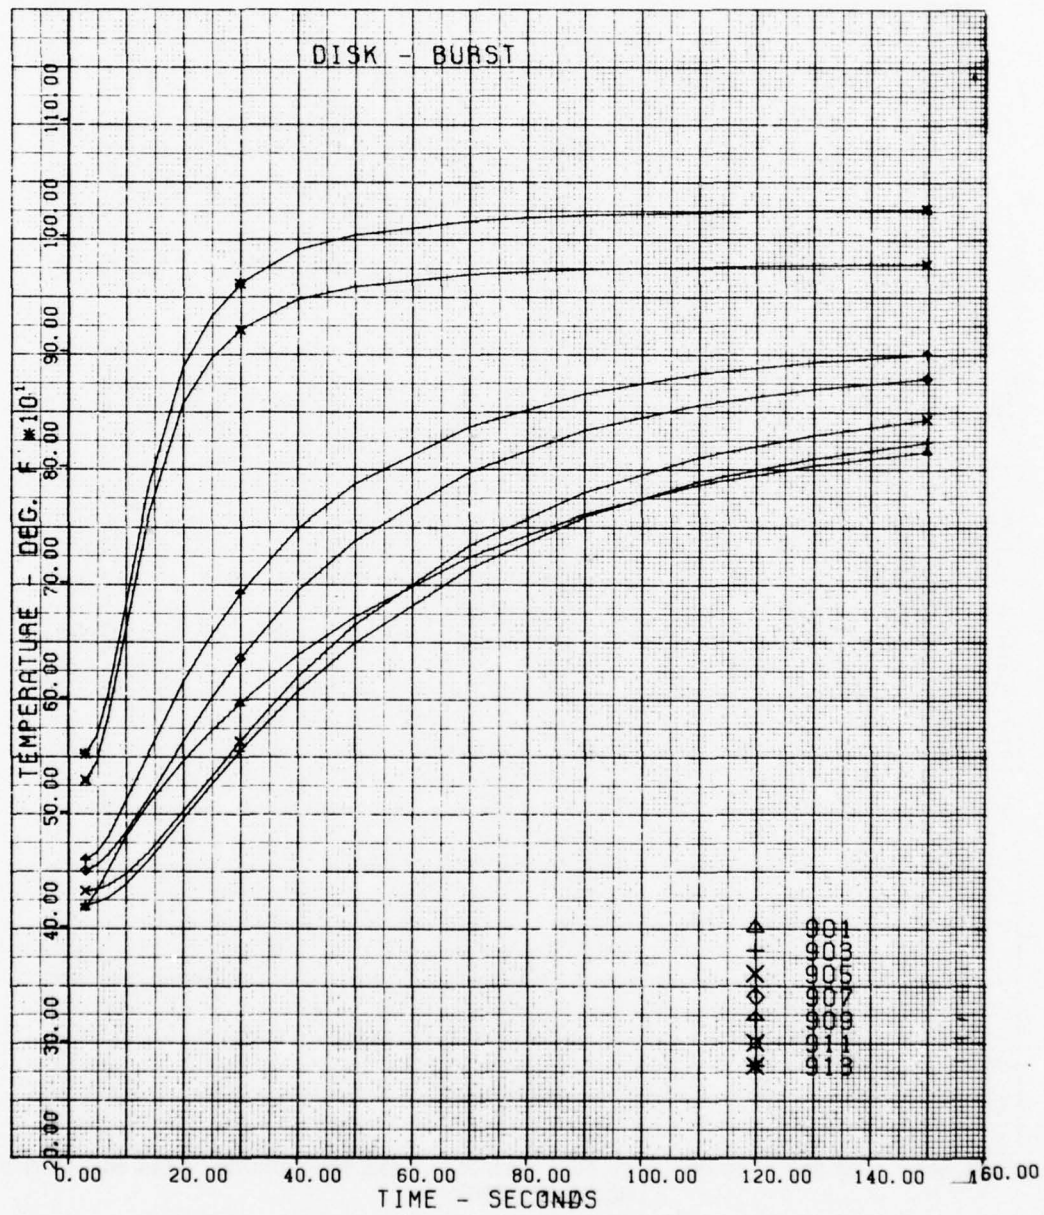
A16. Disk - Burst.

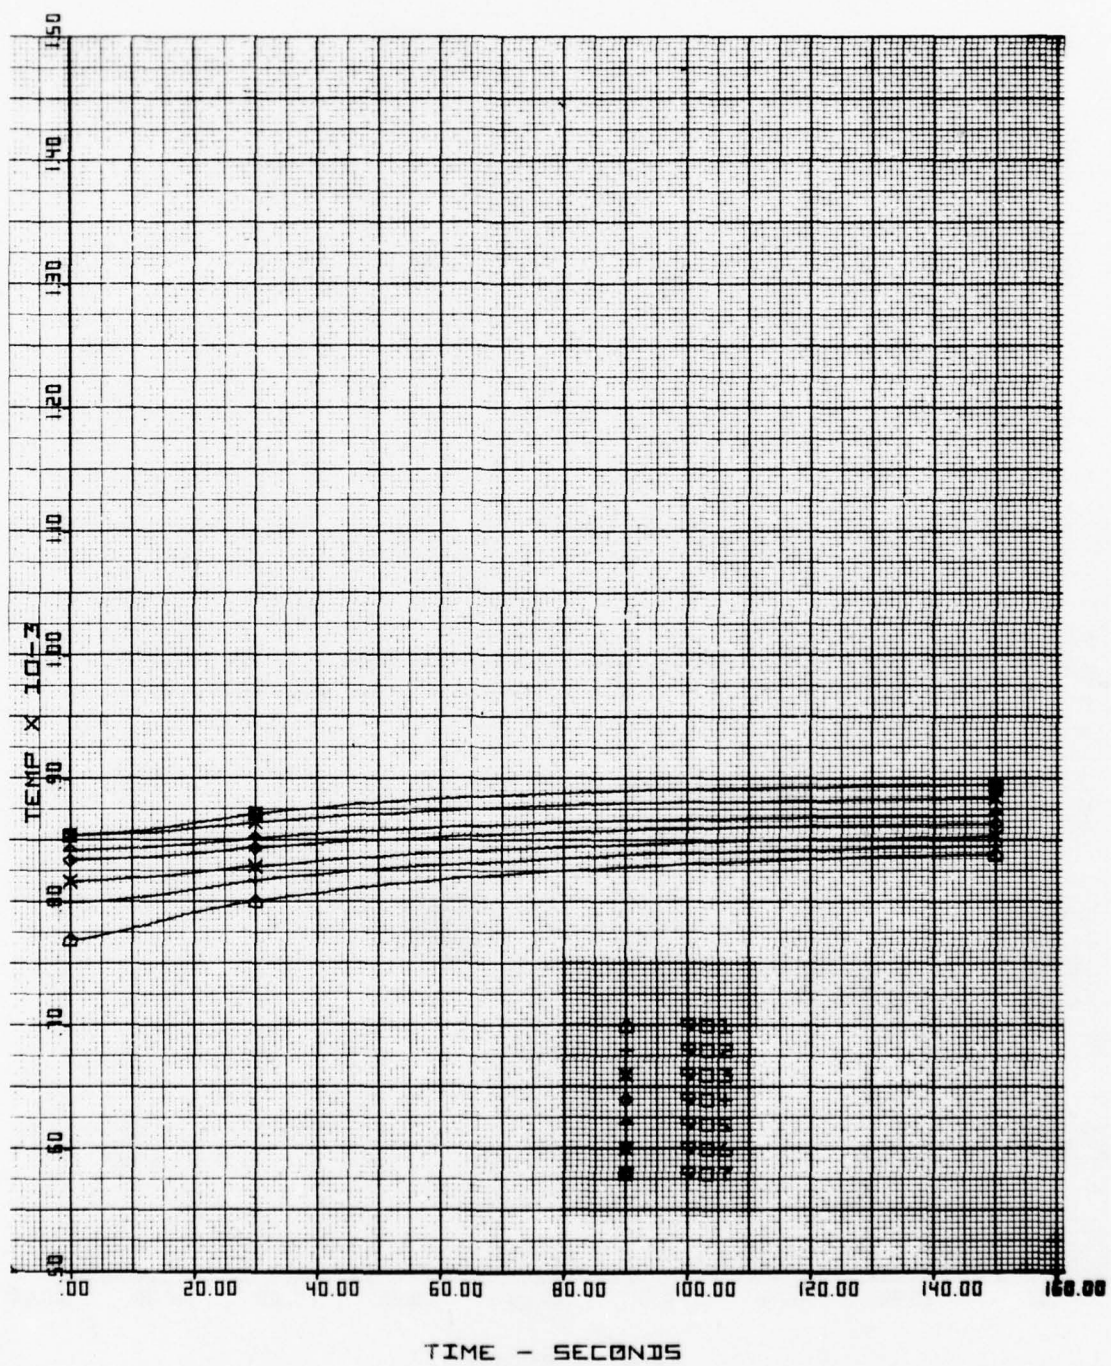
Figure A35. Disk - Reburst.
